Fine Arts Building Update

Measure C Bond Program

**Study Session for the Board of Trustees
October 18, 2011**

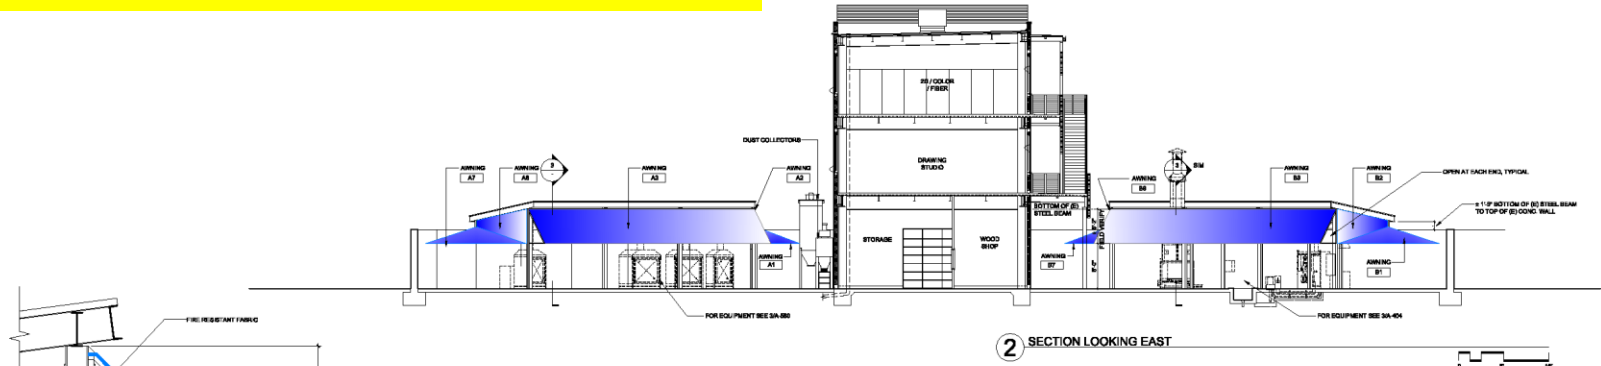
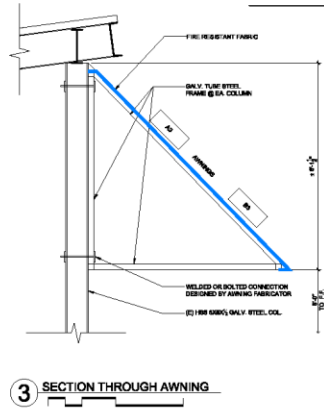
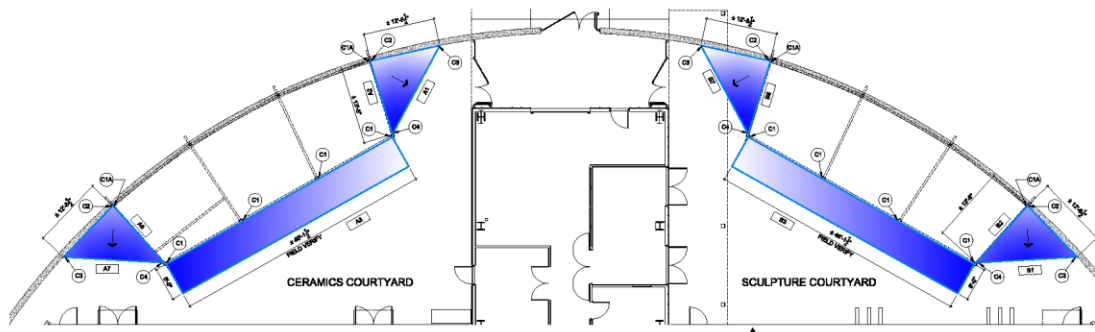
NEW
**FINE ARTS
BUILDING**
COLLEGE OF MARIN
KENTFIELD CAMPUS
S&A APPROVAL
Date: 08/01/11
All Project # 0001 date: 2/20/11
Scale: 1/8" = 1'-0"
PROPOSED AWNINGS
SK-02
PR-57

2a. Kiln and Foundry awnings

AWNING INFORMATION FOR DESIGN / BUILD CONTRACTOR

- AWNING SYSTEM SHALL BE DESIGN BUILD (DB) INCLUDING ALL STRUCTURAL CONNECTIONS. SUBMIT DRAWINGS SHOWING THE PROPOSED CONSTRUCTION FOR DESIGN TEAM APPROVAL. REVISE AS REQUIRED TO OBTAIN APPROVAL.

- DESIGN PARAMETERS
 - REFERENCE CODES
 - 2010 CALIFORNIA BUILDING CODE
 - ASCE 7-05
 - WIND DESIGN LOAD
 - BASIC WIND SPEED = 80 MPH
 - EXPOSURE = C
 - SEISMIC DESIGN LOAD

- SEISMIC CLASSIFICATION = D
 - SHORT PERIOD ACCELERATION, S_s = 1.0
 - LONG PERIOD ACCELERATION, S₁ = 0.8
 - WTC COEFFICIENTS
 - § FA = 1.0
 - § FV = 1.0
 - § I = 1.0

- AWNING MATERIAL SHALL BE SUBMITTED TO THE ARCHITECT FOR APPROVAL AND SHALL BE
 - FIRE RETARDANT - COMPLYING WITH NFPA 701 AND ASTM E84 CLASS A STANDARDS

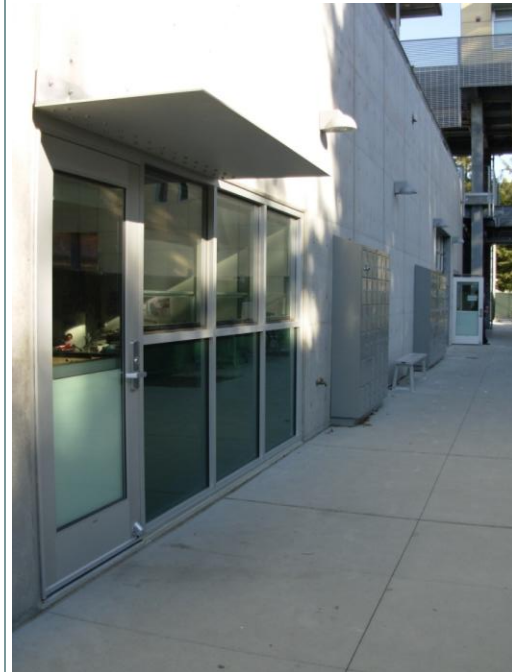
Original concept

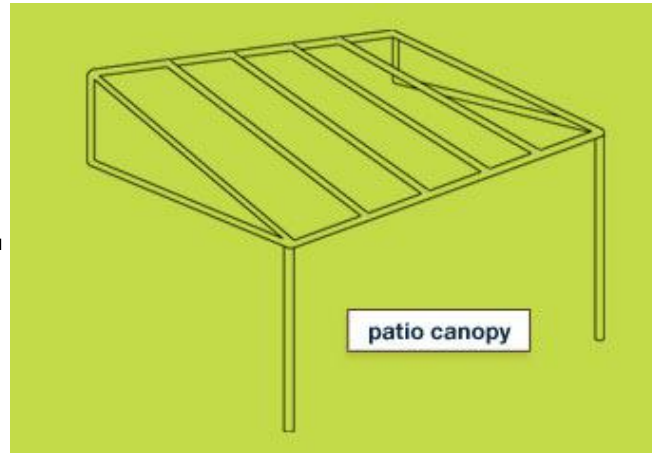
- Without a continuous walkway cover, the only dry place is in front of the Art Office
- The Lockers get wet
- During the worst conditions, wind driven rain can blow into the classrooms
- The central staircase is slippery

Current condition

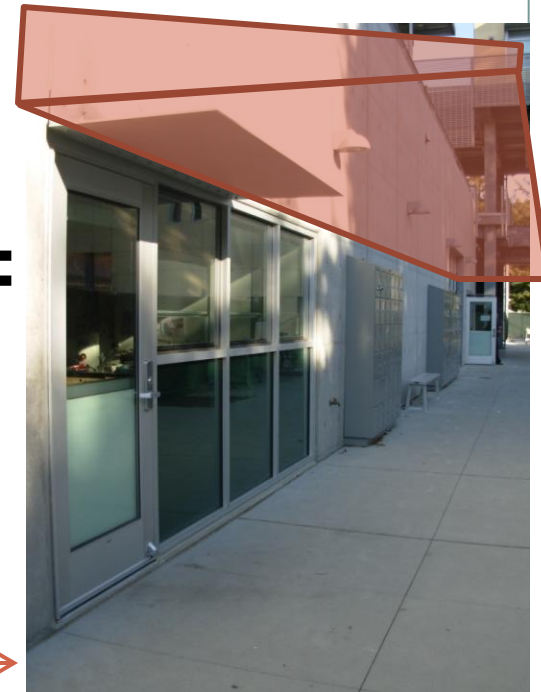
Possible solution

- Without a continuous walkway cover, the only dry place is in front of the Art Office – *add a continuous fabric canopy to the west elevation*
- The Lockers get wet – *fabric canopy will prevent most rain from hitting the lockers*
- During the worst conditions, wind driven rain can blow into the classrooms – *fabric canopy will prevent most rain from hitting the doors*
- The central staircase is slippery – *adding non-slip treads (ongoing)*
- *NOTE: Fabric solution has an 8 year lifespan (similar to kiln/foundry cover) and will require replacement by M & O*

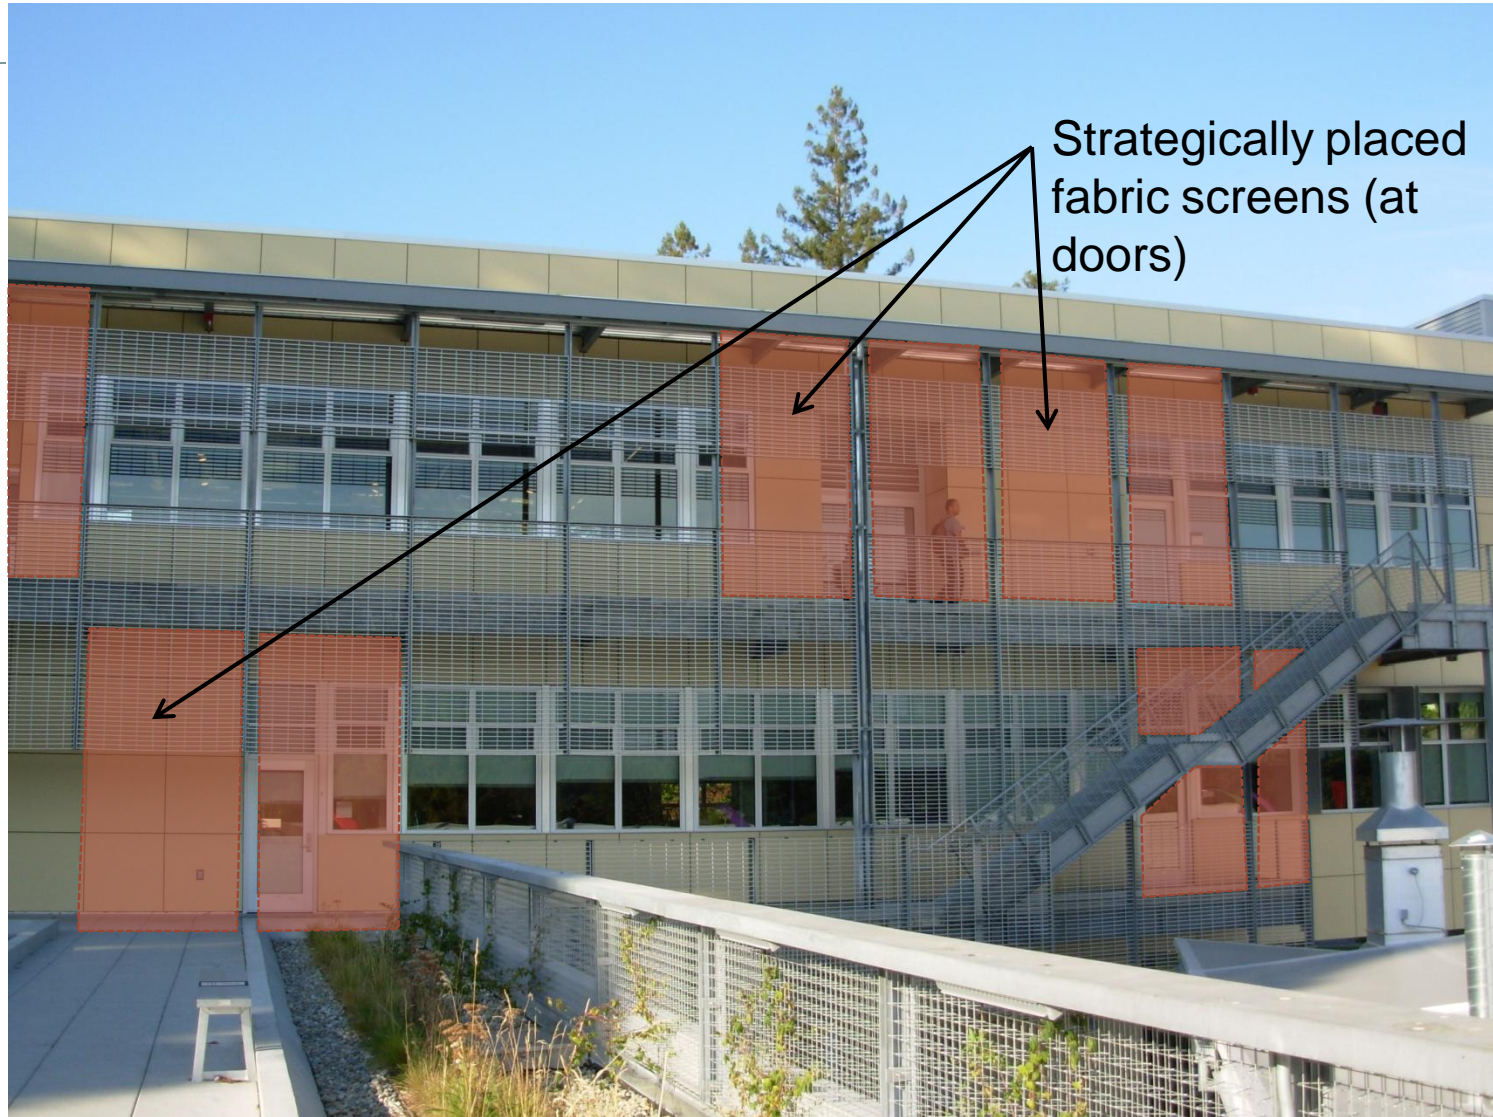
South elevation – 2nd and 3rd floors

- The height of the overhang gives insufficient cover in wind driven rain
- The metal screens collect rain and wind gusts splash it on users
- During the worst conditions, wind driven rain can blow into the classrooms
- The central staircase is not covered

- The height of the overhang gives insufficient cover in wind driven rain – *the existing corridor height cannot be changed, however...*
- The metal screens collect rain and wind gusts splash it on users – *fabric screens can be added to the inside face, preventing wind driven rain from being blown into the corridor*
- During the worst conditions, wind driven rain can blow into the classrooms – *fabric screens, thoughtfully placed, will prevent the rain from entering classrooms*
- The central staircase is not covered – *add a fabric cover*

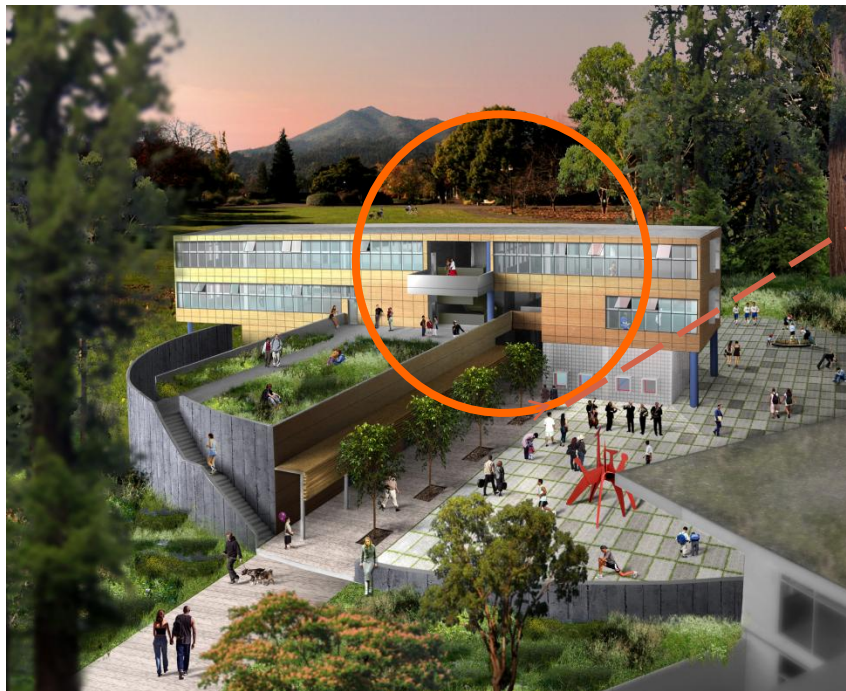
Central Staircase

- Without a roof over the stair, rain water runs down the stair, making the treads slippery
- The metal treads meet code, but with the additional water, the edge of the tread can become slippery

Rendering

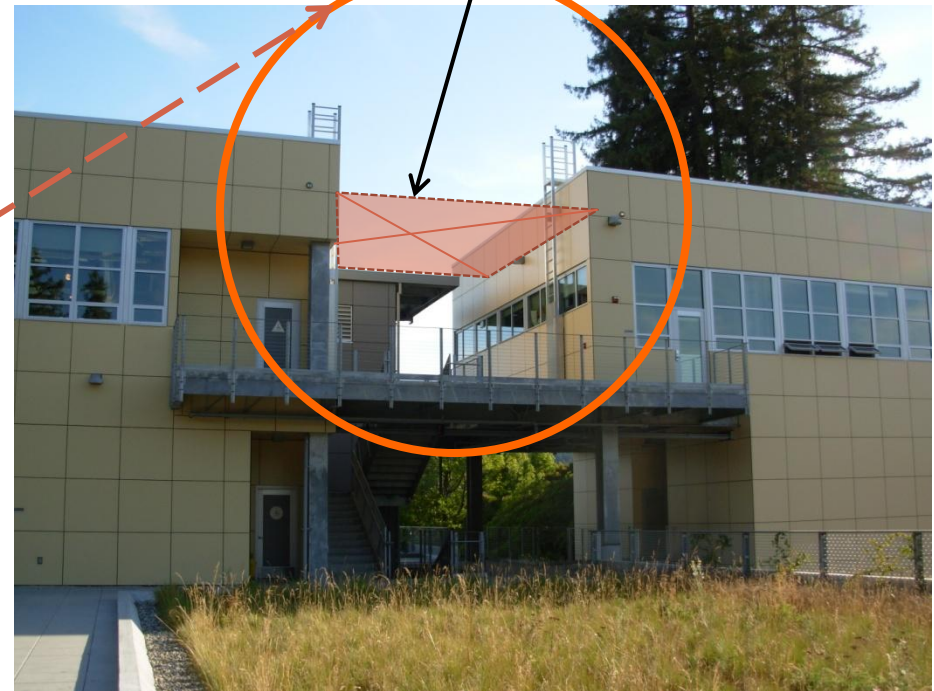
Proposed solution

- Without a roof over the stair, rain water runs down the stair, making the treads slippery – *add a canvas cover over the stair. This reduce (though not eliminate) some of the water.*
- The metal treads meet code, but with the additional water, the edge of the tread can become slippery – *add non-slip tread covers (pricing ongoing)*
